Ultrasonic Pole Inspection Report

Sample Property Report

SUMMARY OF ULTRASONIC POLE INSPECTION

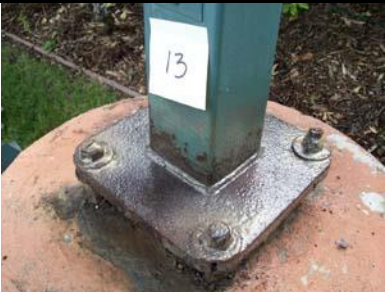
Pole 13	Test Data	Nominal	0.131	Flag	0.118

Pole #	Rating	Notes	Pole #	Rating	Notes
11	Below Acceptable Standards		14	Acceptable	
12	Below Acceptable Standards	Anchor Bolts need to be replaced	15	Acceptable	
13	Marginal	Anchor Bolts need to be replaced	16	Below Acceptable Standards

Anchor Bolts need to be replaced
	0.128		0.125			
	0.134		0.120			
	0.130		0.122			
	0.131	0.121

0.128		
	0.129	0.120		0.136		
	0.132	0.119		0.118		
			0.125			
			0.131			
			0.125

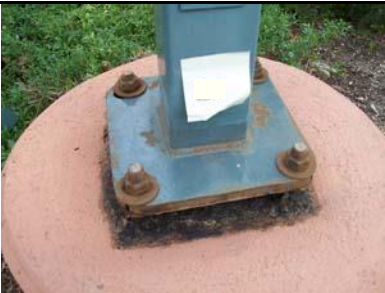
Pole 15	Test Data	Nominal	0.131	Flag	0.118

0.128		0.122			
	0.134		0.124			
	0.130		0.131			
	0.131	0.136

0.120		
	0.129	0.125		0.121		
	0.132	0.121		0.123		
			0.121			
			0.121			
			0.126

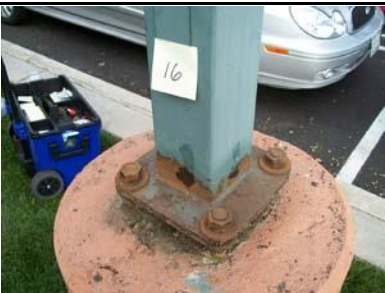
Pole 16	Test Data	Nominal	0.161	Flag	0.145

0.174		0.145			
	0.166		0.138			
	0.160		0.129			
	0.161	0.152

0.140		
	0.161	0.118		0.146		
	0.142	0.134		0.129		
			0.155			
			0.126			
			0.135

1. **Replace missing mounting hardware** (washers & nuts) for pole locations #40, 41, 42, 43, 44, 51, 53, 54, 55, 56, 58, 59.
2. **Remove & replace 6 poles #11, 12, 16, 31, 42 and 50** rated as “Below Acceptable Standards”
3. **Repair concrete bases for 4 pole locations.** Repair existing concrete bases at poles #35, 36, 37, & 38 to allow for proper moisture drainage. These (4) four poles have a convex top, allowing water to pond at the anchor bolts. Poles will require new anchor bolts once the concrete is repaired.
4. **Replace Rusted Anchor Bolts for 8 poles** 12, 13, 35, 36, 37, 38, 45 & 46
5. **Schedule another inspection for the entire property approximately 12 months** from now paying special attention to the poles rated as “Marginal”.
6. **Instruct landscaping company to redirect sprinkler heads away from pole bases** 37, 38, 45, 46, 47, 48, 51, 52, 53, 54, 55, 56,

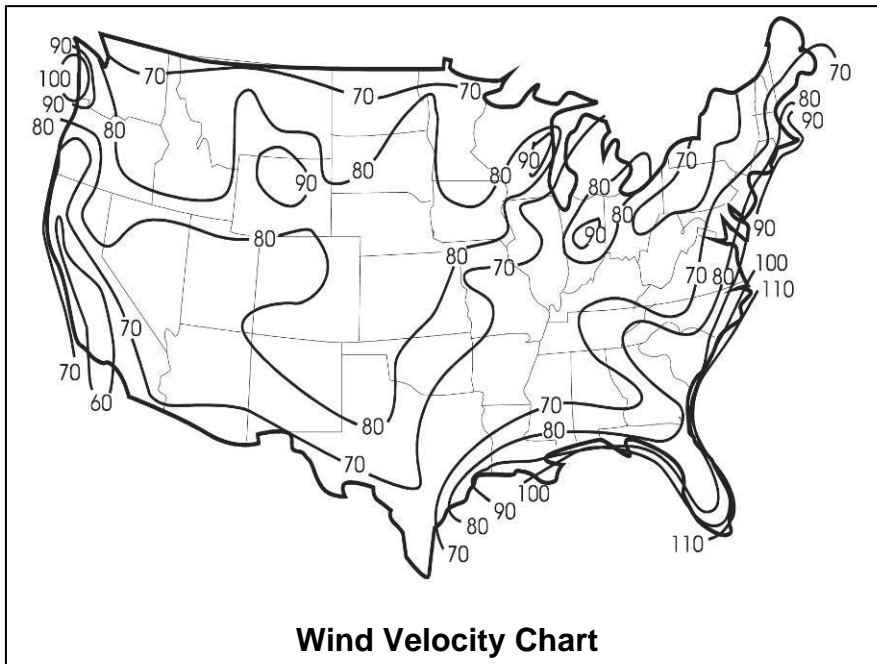
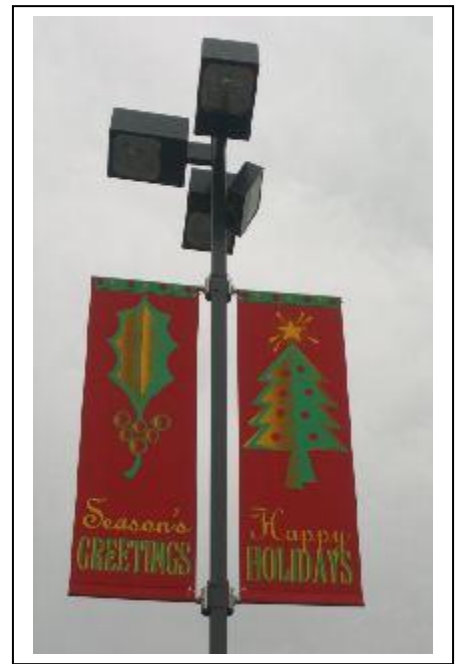
Poles are design to withstand certain wind velocity ratings. Overloading the pole with too much weight, in addition to banners, flags and signs hanging on the pole can cause the pole to fail (fall over). Banners can act as parachutes or sails, adding stress to already weak rusted pole bases.

SANTA ANA WINDS
