Ultrasonic Pole Inspection Report

Sample Property Report

SUMMARY OF ULTRASONIC POLE INSPECTION

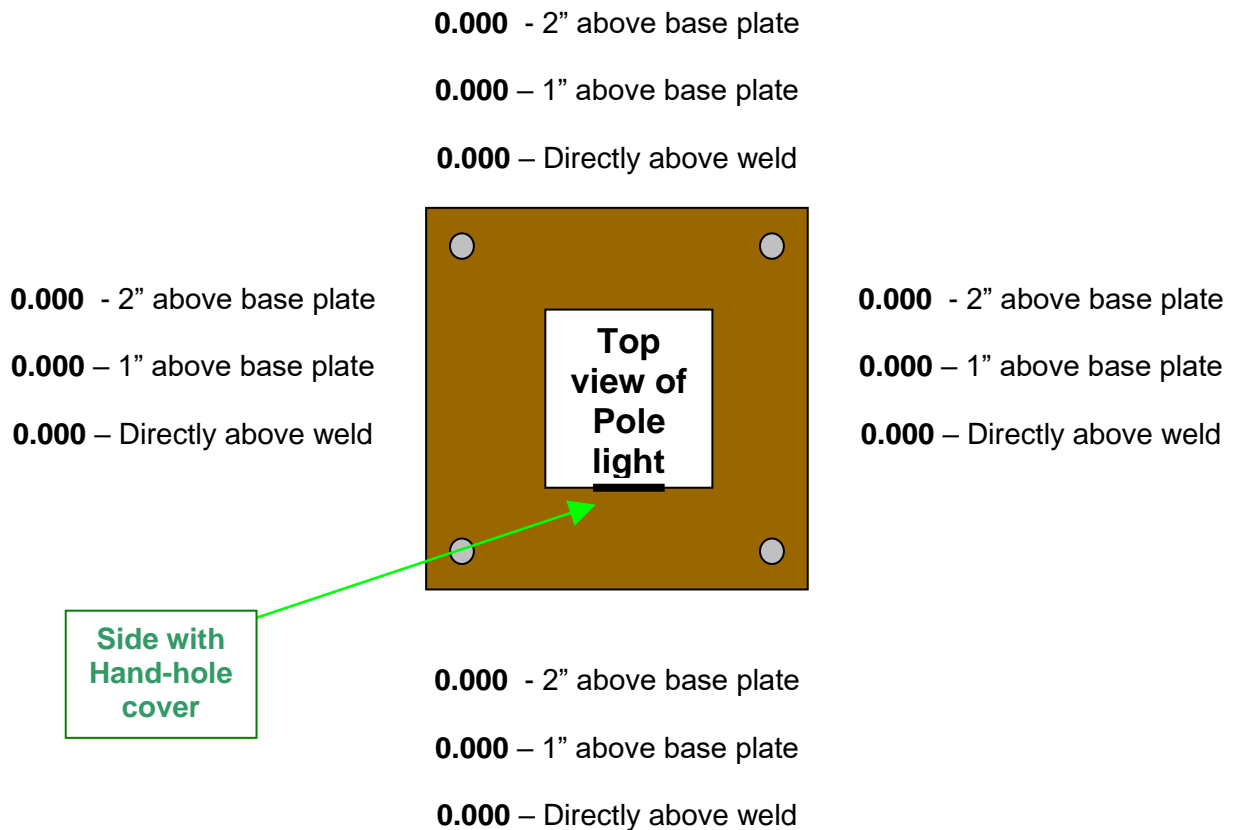
A total of (12) twelve readings are taken at the base of each pole. The readings are shown from top to bottom, the first (top) reading being taken at roughly 2 inches above the weld of the base plate. The second (middle) reading is taken roughly 1 inch above the weld of the base plate. The third (bottom) reading is taken just above the base plate weld. This same procedure is used on every side of every pole.

To determine the nominal thickness, several readings are taken around the pole approximately (5) five feet above the base plate. From this nominal thickness, a "flag" is set for any reading that falls below 90% of this nominal reading. Due to tolerances in manufactures specifications, this nominal thickness will vary from pole to pole. Additionally, each property may have several different pole types and manufactures. Therefore each pole is tested to determine its own unique nominal and flag readings.
